# Kirchbichl Unit 4 - Looking for efficiency permille and not seeing the missing percent

G. Höfer, B. List, H. Götsch

## 1. Abstract

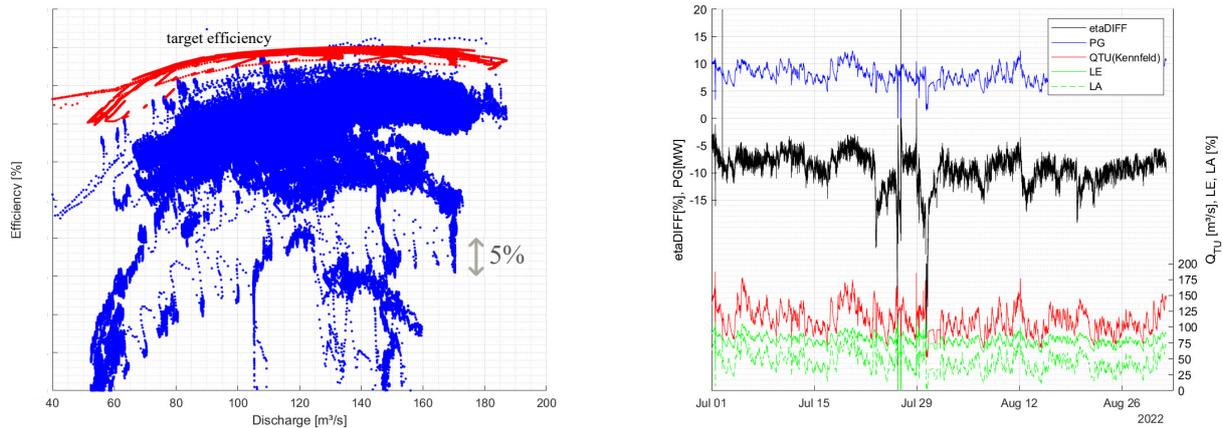
**Figure 4 Efficiency Curve, July – September 2022**

The following diagram illustrates the representative range of efficiency achieved in 2022 in comparison with the target efficiency (left). The diagram on the right depicts the time curve of the efficiency deviation from the target ( $\eta_{\text{DIFF}}$ ), the generator output (PG), flow rate (QTU), position of the guide vane (LE) and runner (LA). The efficiency is calculated as follows:

Figure 3 shows that the efficiency deviation over time is, on average, -10%. However, there are instances where it can improve or deteriorate by 5% in a relatively short period of time. This phenomenon can also be observed in the characteristic curve, where the scatter band is up to 10%, with the average deviation also approximately -10%. It is noteworthy that the deviation across the entire flow band reaches a similar absolute value. It would be expected that losses from the flow or due to vortex intake would show a certain dependence on the flow rate or speed; however, this is not the case.

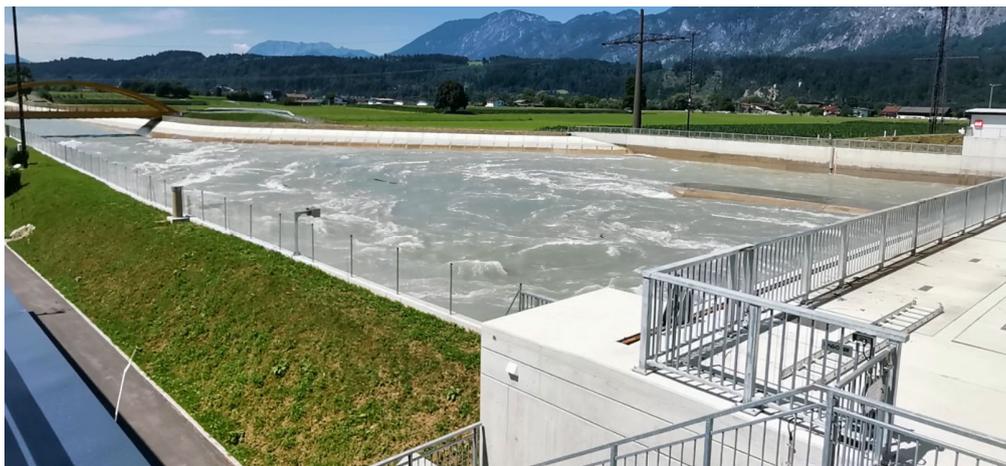
**Figure 5 Operation with lowered head water level**

Even though the hydraulic model tests have already shown that a deterioration of the inflow is more likely to be expected with non-overflowed piers, a test was carried out with a lowered level. For this purpose, the level in the forebay was lowered below the upper edge of the pier and operated with unit 4. The flow in the forebay changed, but this had no major influence on the efficiency of unit 4.

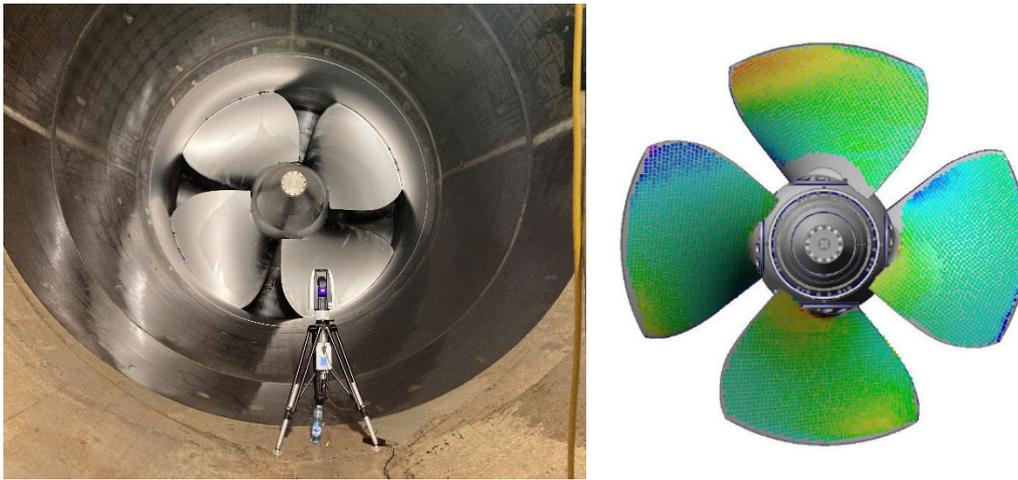
Figure 6 3D Scan and comparison to nominal design values

The entire runner geometry was scanned by VOITH HYDRO using 3D laser scanning. This measurement was carried out in different positions in order to check the correlation of the indicated opening as well as the runner / blade geometry in general. The results of the scan were compared with the 3D model. Both the hydraulic contour and the absolute positions showed virtually no deviations compared to internal or IEC standards.

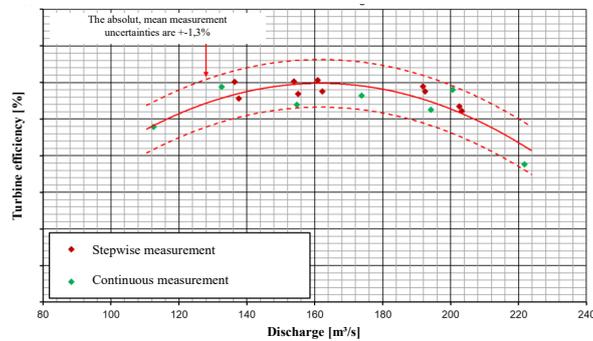
**Figure 9 Results of the efficiency measurement [6]**

- The measured efficiency is on average approx. 3% below the guaranteed values.
- The measurement uncertainty was determined to +/-1.3%.
-

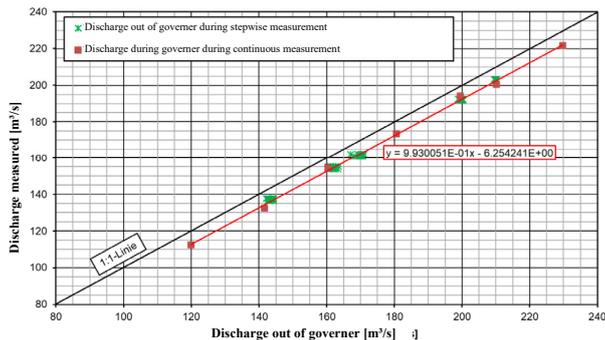
**Figure 10** Flow measurement vs. governor value [6]

The actually measured flow rate is generally  $-7.5 \text{ m}^3/\text{s}$  lower than the value indicated at the governor over the entire discharge range.

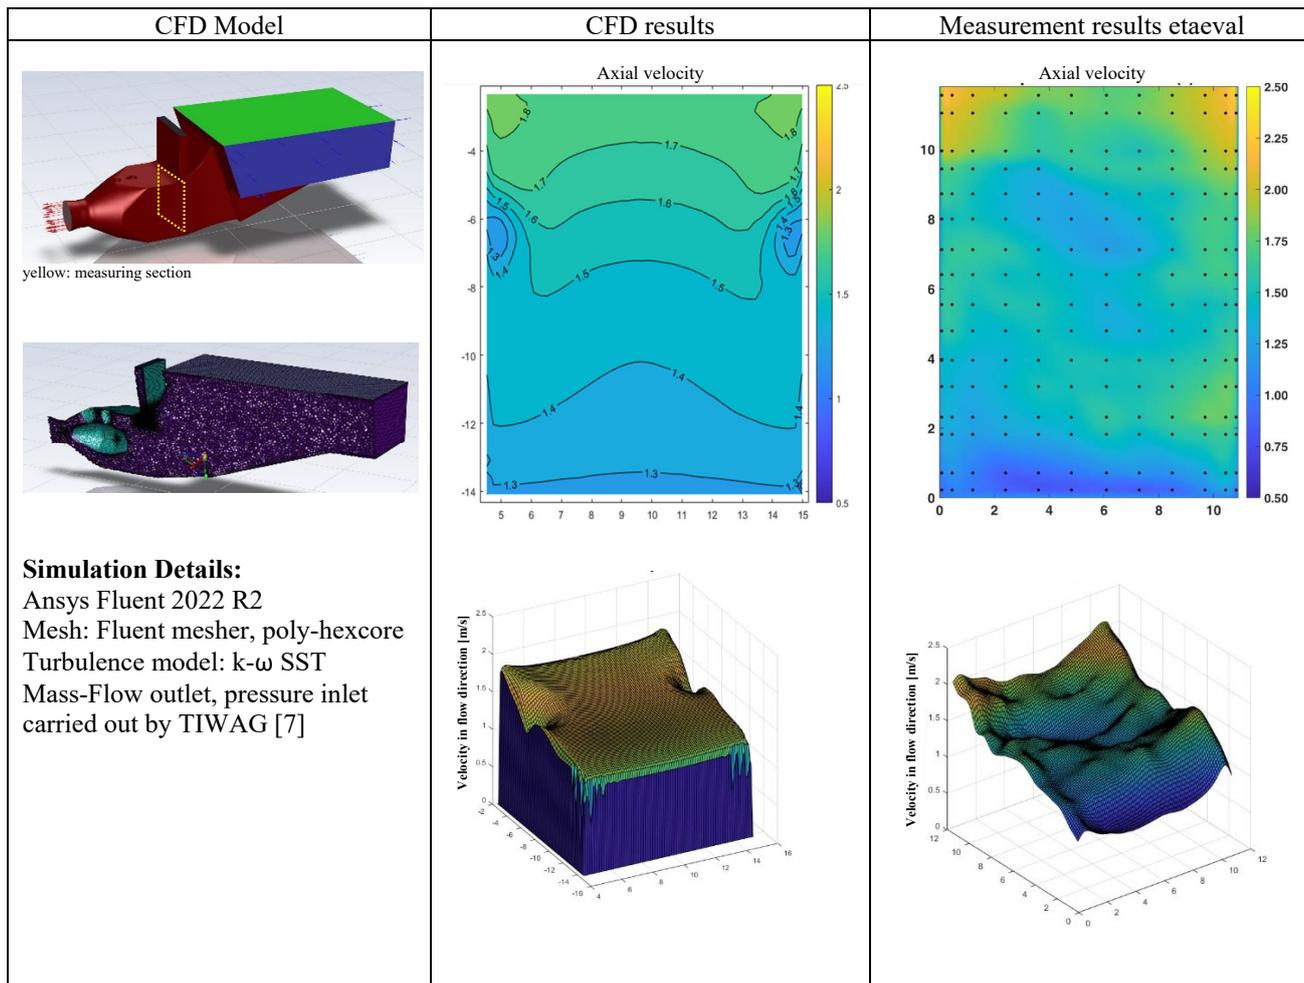
**Figure 11** Comparison of measurement and CFD of a symmetrical inflow without pillars [7]

The discrepancy between the actual and target efficiencies was attributed to the suboptimal inflow in comparison to the inflow criteria of Fischer-Franke [3]. The measurement showed asymmetric inflow fields which could not be directly evaluated according to its efficiency impact. Thus, an ideal CFD model was set, which only shows the inflow field induced by the intake of unit 4. The CFD with the ideal model was performed to evaluate the impact of the pillar and the asymmetrical forebay.

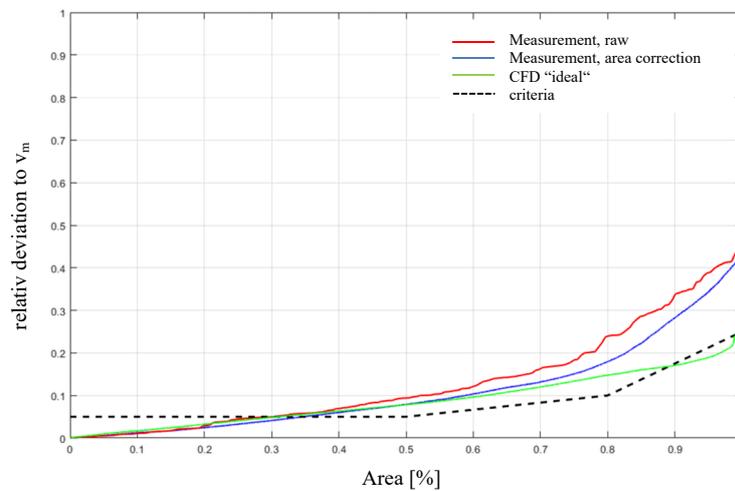
Figure 12 Fisher-Franke criteria, CFD vs. measurement

The results show that neither the ideal CFD model nor the measurement did fulfill the criteria according velocity conformity. Figure 12 shows the relative deviation of the single velocities to the mean velocity in the measuring section. The curve “area correction” refers to a discretized flow field derived from the raw data with unequally spaced propeller positions and measuring levels. This allowed for an equal weighting factor of every point. Even if the deviation is smaller, the velocity distribution of the ideal model cannot fulfil the criterion either.

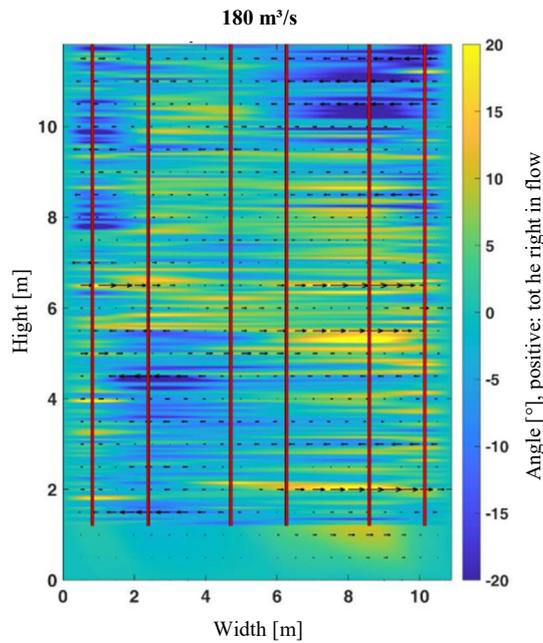
Figure 14 Horizontal flow direction angle at measuring frame

The angle sensors have allowed for monitoring the horizontal main flow direction as well as the occurring fluctuations. The angle sensors had little damping and were directly exposed to vortices. However, the angle signals fluctuated in a range of +/- 20° in some areas of the inlet. Especially in the upper part of the section, fluctuations were constantly high at the whole operating range of unit 4.

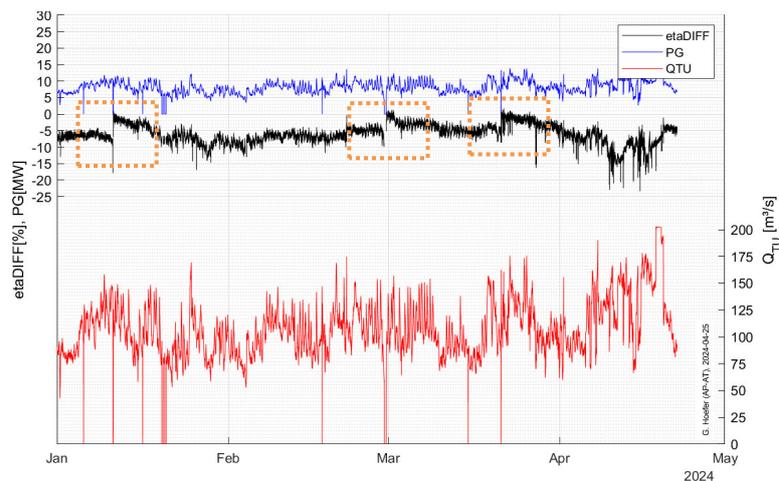
Figure 15 Efficiency deviation over Time, Jan – May 2024

This phenomenon has been previously documented and became evident by postprocessing the long-term data. Using the efficiency test results to correct the turbine flow by 7.5 m<sup>3</sup>/s, showed that the efficiency was close to the guarantee value during these short periods.

In the aforementioned evaluation, which spanned the period from January to May 2024, the unit was deactivated on three occasions. Following each start of the unit, the deviation from the target efficiency is almost 0%. During the following days the deviation gradually became bigger until the next unit shut down. During the operational phase, self-healing effects are observed on numerous occasions, typically resulting from significant fluctuations in output within a relatively short

timeframe. Such occurrences result in an immediate improvement of the efficiency, but does not fully reset to its nominal status, like it happens in the case of a unit shutdown.

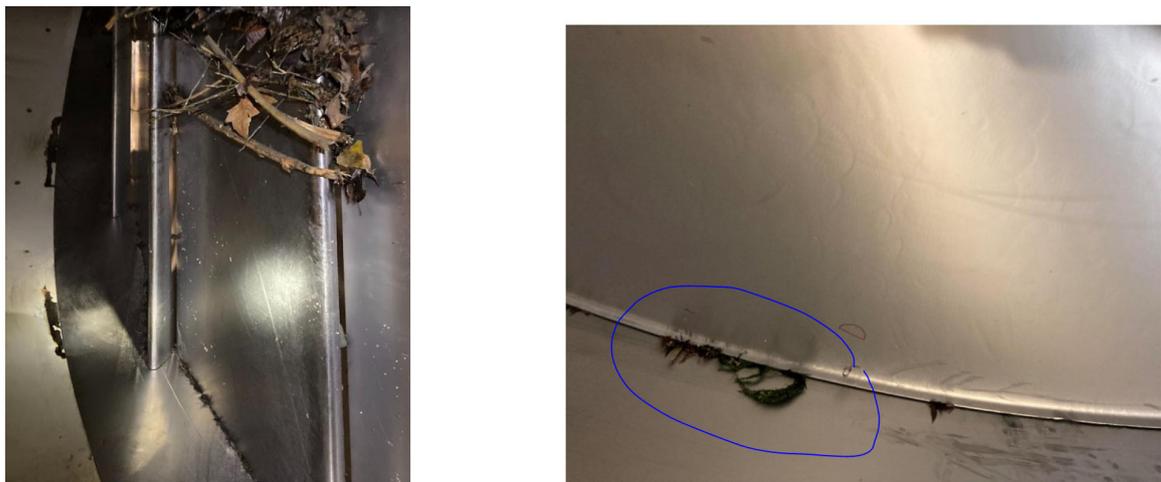
Figure 16 Guide vanes (left) and runner gap (right) during inspection 2021 [8]

Assessing photo documentations showed flotsam, such as small branches and leaves around guide vanes and runner blades. This flotsam is mostly removed during the shutdown procedure and thus an inspection of the waterway does not show these parts every time. However, after assessing photos and inspection reports the reduction in efficiency could be attributed to this fouling from flotsam, such as small branches, leaves, etc. The trash rack spacing is 85 mm, which only prevents larger debris from entering the waterway. The significant impact of this flotsam has also been described by Staubli and Abgottspon [9].

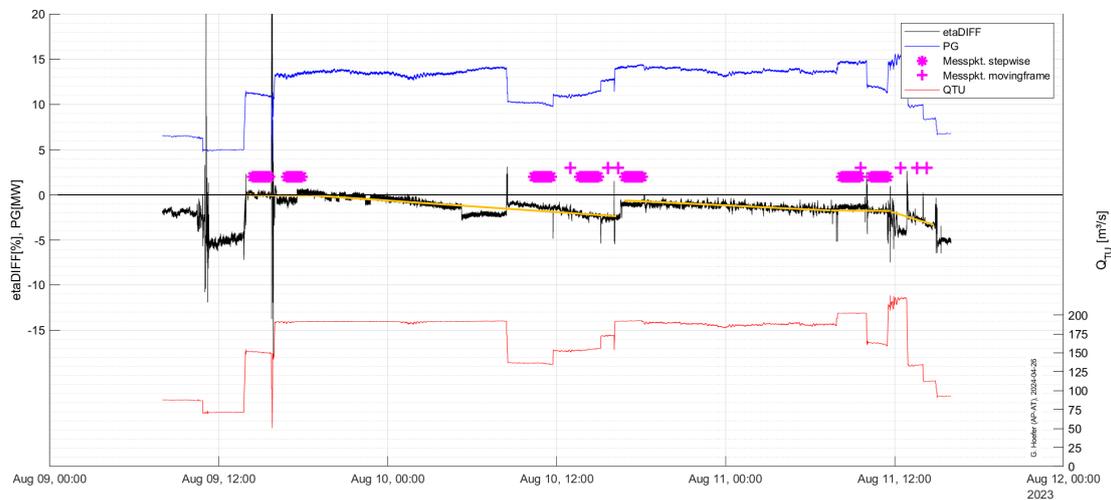
Figure 17 Soil impact during efficiency measurement

Prior to the efficiency measurement, the unit was shut down for several days due to flooding. Consequently, the initial efficiency values observed at the outset of the measurement period were likely artificially elevated, and these values subsequently declined over time.

The subsequent diagram illustrates the temporal evolution of the efficiency deviation during the measurement campaign. It is evident that the efficiency has exhibited a continuous decline over the measurement period, following an initial period of elevated values. The individual measuring points derived from the step-by-step and moving-frame methods are represented in purple.

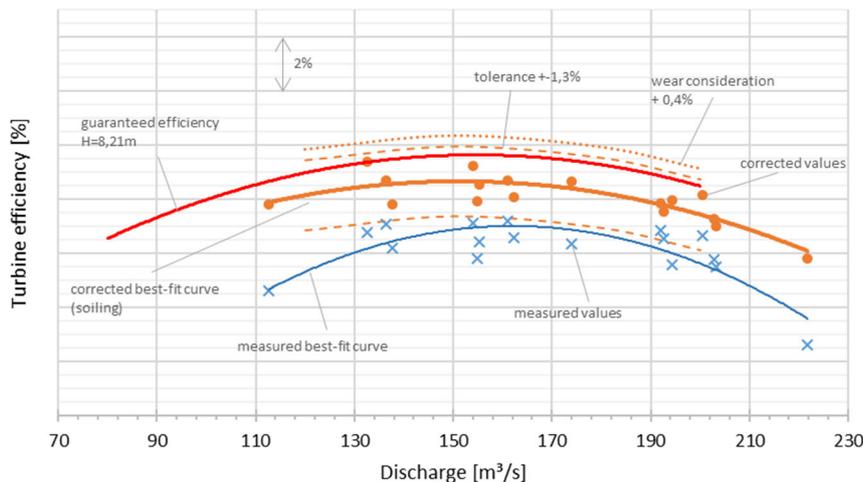
Figure 18 Efficiency over Time during efficiency measurement in Aug 2024

Correcting the gradual efficiency drop during the propeller measurement shows that the curve's characteristic is corresponding to the guarantee. If the measurement tolerance and the abrasive wear at the runner gap and at the runner leading edges are taken into account, the unit fulfills the guarantee values.

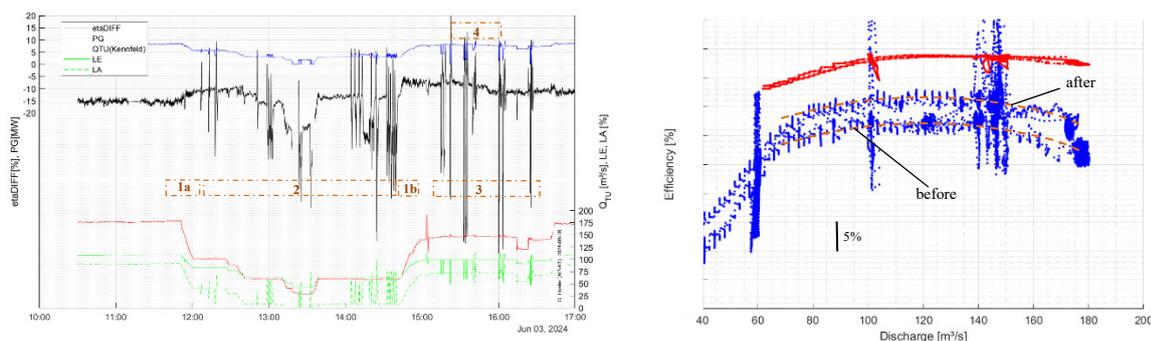
Figure 19 Efficiency over Time during efficiency measurement in Aug 2024

Ad 1a) The significant change in capacity from approx. 190 m<sup>3</sup>/s to 100 m<sup>3</sup>/s resulted in a noticeable improvement in efficiency of approx. 5%.

Ad 2) With very low opening of the guide vane of up to 40%, the runner was opened up to 100% several times in a short time. In some cases, a return power of up to 1.8 MW was achieved. The vibrations were greatly increased. However, a noticeable improvement in efficiency was not achieved.

Ad 1b) The renewed increase in output from approx. 75 m<sup>3</sup>/s to 150 m<sup>3</sup>/s again resulted in a significant improvement of approx. 5%.

Ad 3) At a runner position of approx. 70%, the guide vane was opened to 110% and also closed to up to 50%. A noticeable increase in performance could only be achieved to a limited extent, The efficiency increased by approx. 3%.

Ad 4) During the tests, the automated cleaning unit began to clean the inlet screen on unit 4. It was clearly evident that the efficiency dropped by several percent with each cleaning stroke. The cleaning of larger floating debris probably loosened smaller branches, which then travelled through the screen to the unit.

Overall, the flushing programme increased the efficiency by approx. 5%. However, it cannot be ruled out that this was mainly caused by the strong changes in the unit's performance rather than by the transient movements outside the context.
