**Spillway Discharge Measurements by
Acoustic Scintillation Flow Meter in Spillway B at Mellanfallet Dam,
Alvkarleby Hydro Power Station, Sweden,
August, 1999**

Swedpower AB
SE-814 26 Alvkarleby
Alvkarlebylaboratoriet,
Sweden

W. W. Cartier, D. D. Lemon and R. A. Chave
ASL Environmental Sciences Inc.
Sidney, B.C. V8L 5Y3
Canada

ASL File No. 76-416-L

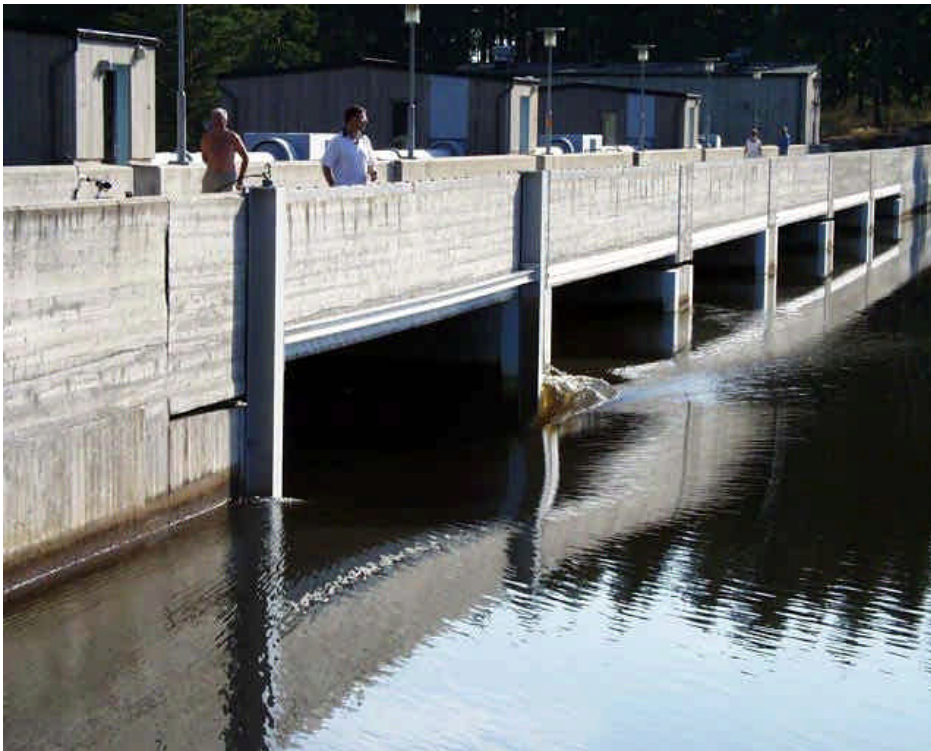
Figure 2-5: Flow through spillway opening during vibration testing (no fairings present).

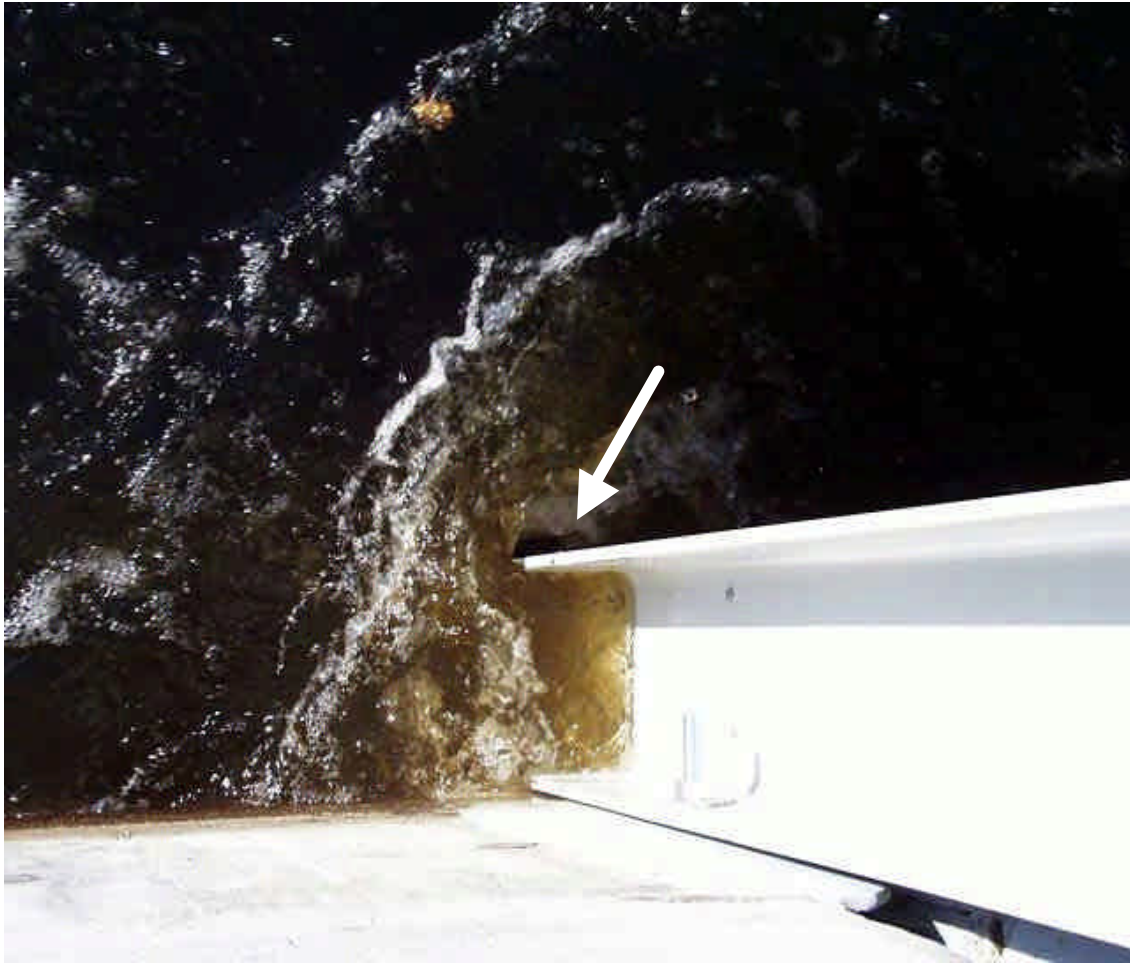
Figure 2-6: Entrainment of air around frame during vibration testing (indicated by white arrow).

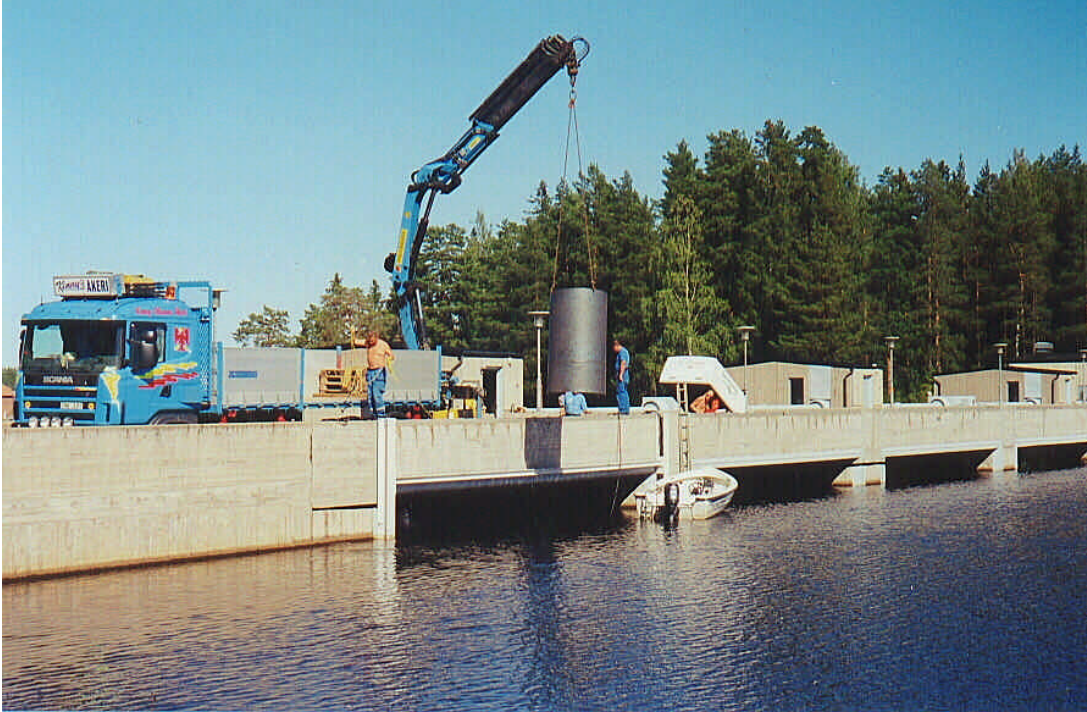
Figure 2-8: Transducer support frame fairings being installed prior to flow measurements.

Despite the installation of the semi-circular plates, as shown in Figure 2-8 and Figure 2-11, the vortices formed by the flow contraction around the H-beams caused air entrainment down past the upper pair of transducers at full gate opening, so that no acoustic signals were received on that level.

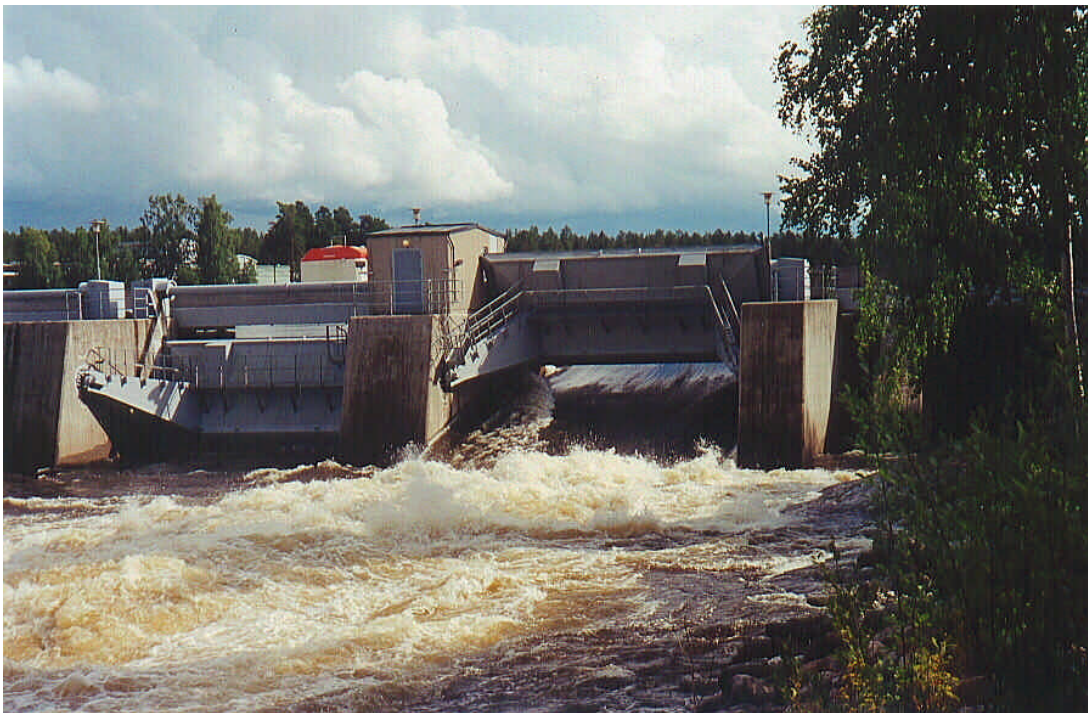
By the end of Wednesday August 17th, the support frames had been installed in spillway B, along with the fairings which were mounted after the support frame had been attached to the face of the spillway (Figure 2-8). Figure 2-11 shows the resulting flow around the fairings, which unfortunately did not completely solve the air entrainment problem. Gate

openings greater than 1m resulted in unusable upper levels. Figure 2-9 shows the spillway in operation with the spillway gate fully open.

Figure 2-9: Spillway B in operation during flow tests..

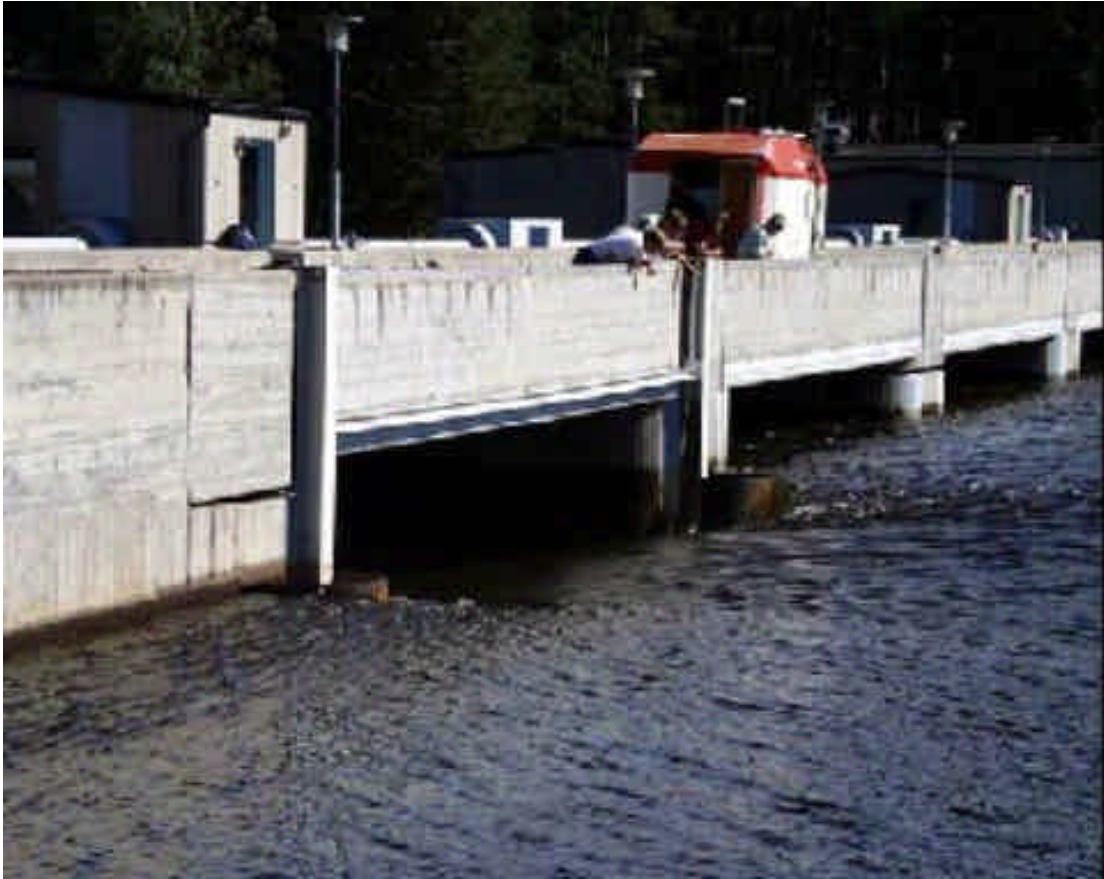
Figure 2-11: Flow around fairings during flow measurements.

It is believed that the addition of the metal fairings, which were put in place to help alleviate the extreme draw-down adjacent to the upper level transducers, caused a boundary separation upstream of the transducers. Figure 4-21 shows a pictorial of this process which resulted in a re-circulation region between the boundary layer separation point and the transducer face (on both sides of the spillway) resulting in a non-uniform distribution of turbulence intensity along the acoustic path joining the transmitters and receivers at all levels. It is fundamentally important to have a uniform distribution of small-scale turbulence intensity along the acoustic path or the regions of flow

The ASFM technique shows promise for directly measuring spillway capacity, but the method of mounting the sensors must be improved so that vortex formation and the introduction of air in front of the sensor faces is prevented. Otherwise, as was seen at Alvkarleby, it is not possible to measure the maximum discharge capacity, which is the quantity of interest. Methods to improve the sensor installation are presently being studied, with the intention that a new test can be performed to measure the absolute maximum discharge.

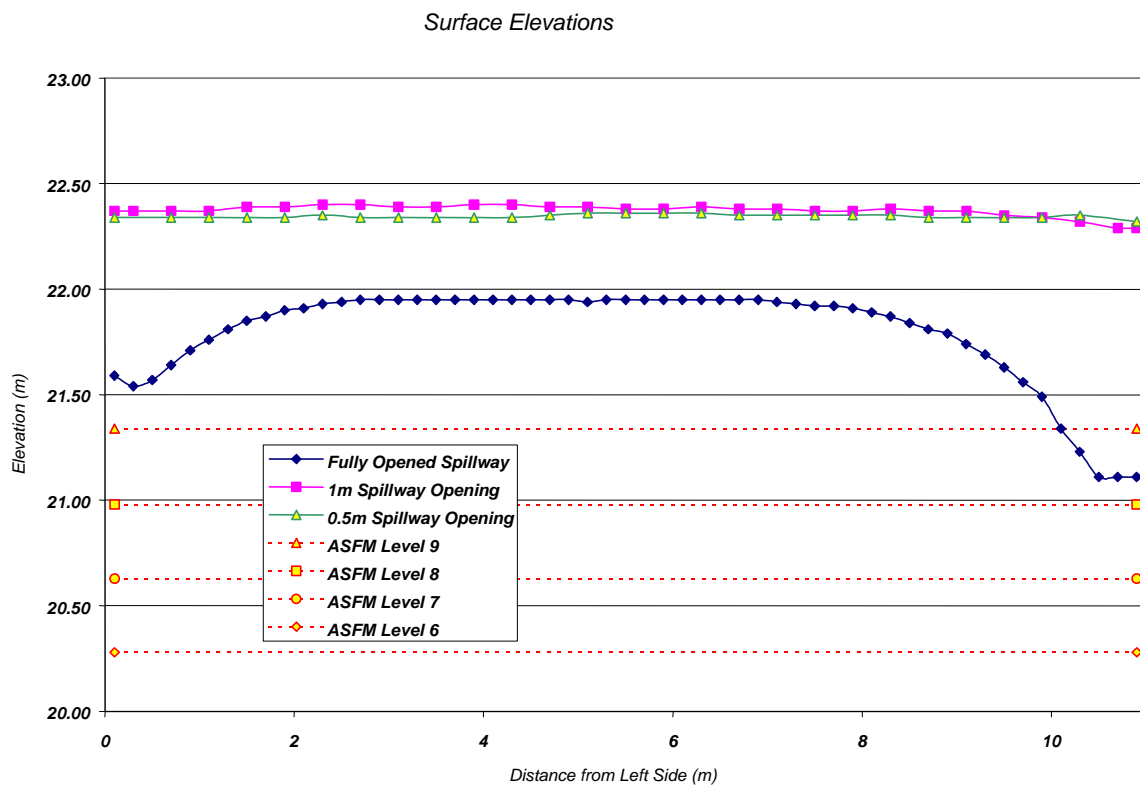
elevation data was not available for the 0.75m gate opening). Figure 4-1 shows the plots of these data in relation to the four upper most ASFM measurement levels, level six, level seven, level eight and level nine.

The draw down effects can clearly be seen in Figure 4-1 for the fully open gate on the extreme right side of the spillway down below the top most transducer of the ASFM. This does not show the severity of the air entrainment, which extended down past the several of the upper levels of the ASFM system rendering the data unusable.

Figure 4-1: Surface profiles for 0.5m, 1.0m and fully open gate positions.

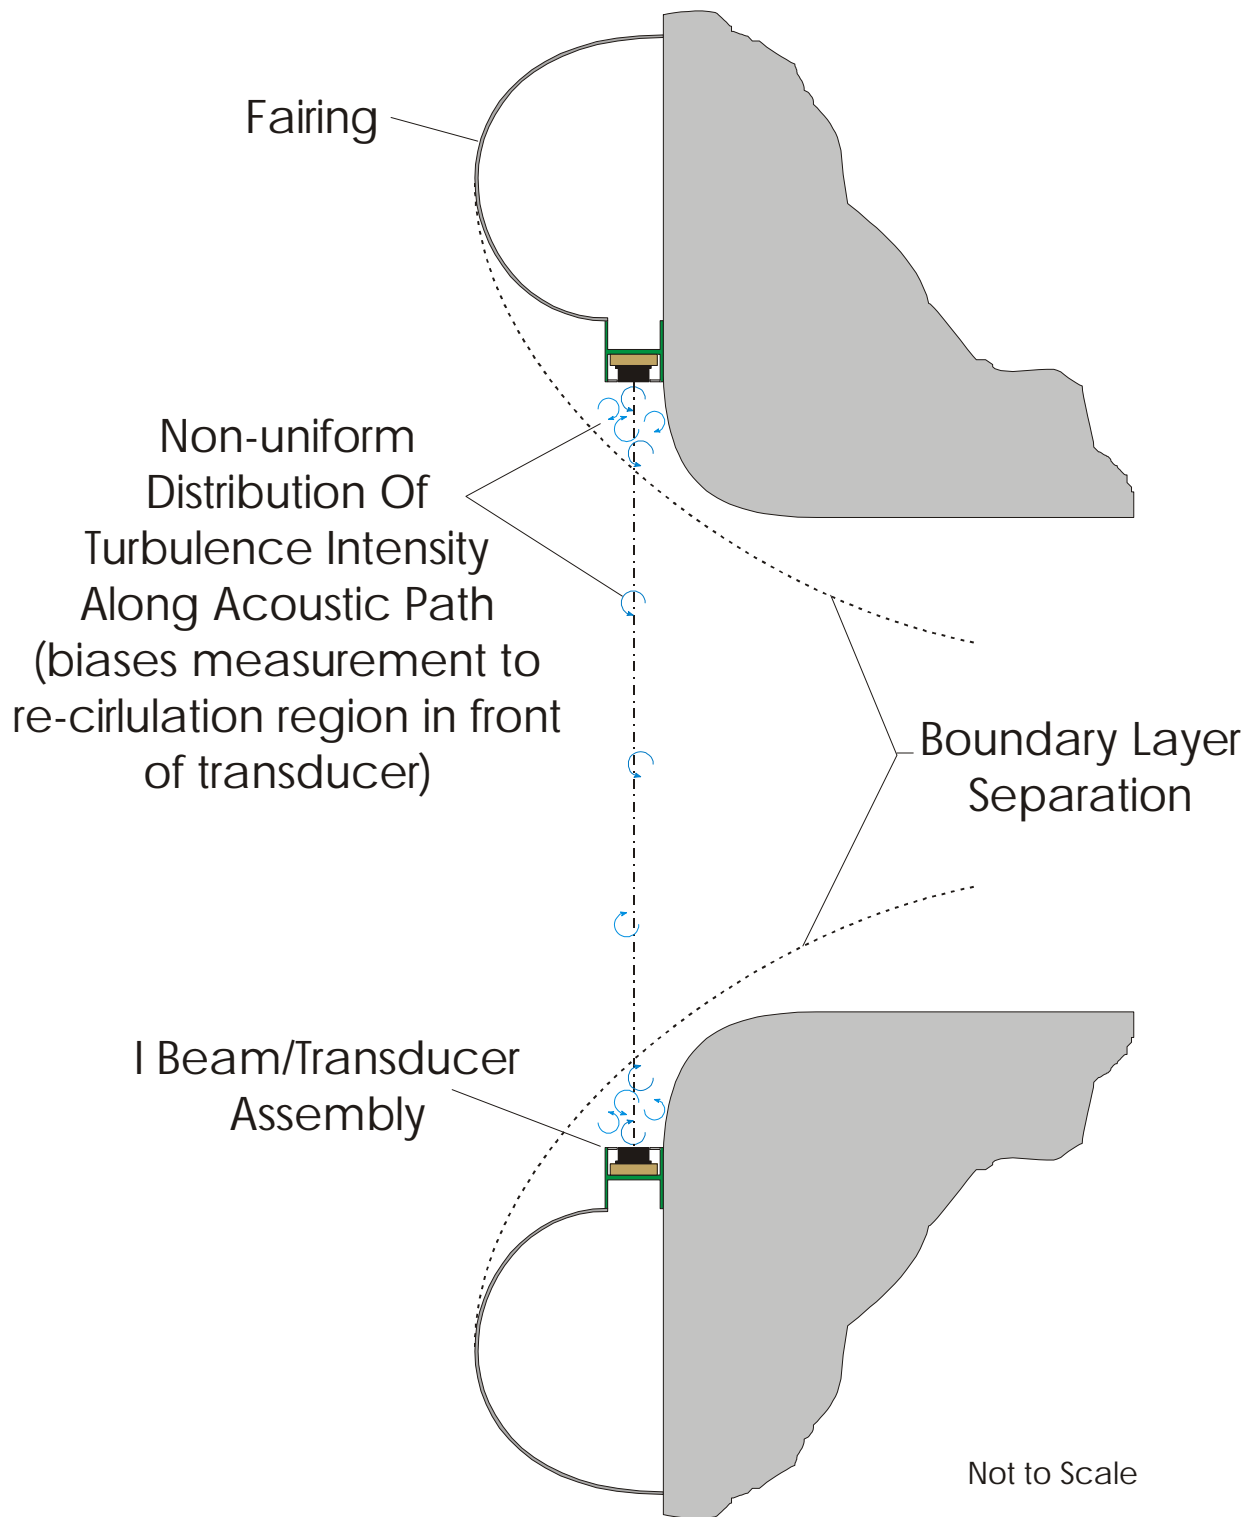
containing the more intense turbulence will bias the velocity estimate since the system is sensitive to a very narrow range of turbulent eddy sizes. Since the region of flow within the boundary layer is experiencing re-circulation and contains more intense turbulence than is in the flow outside of the boundary layer, the velocities would be estimated low resulting in lower discharge estimates.

Figure 4-21: Diagram showing boundary layer separation from fairings and resulting non-uniform turbulence distribution along the acoustic path.
