# Kirchbichl Unit 4 - Looking for efficiency permille and not seeing the missing percent

G. Höfer, B. List, H. Götsch

## 1. Abstract

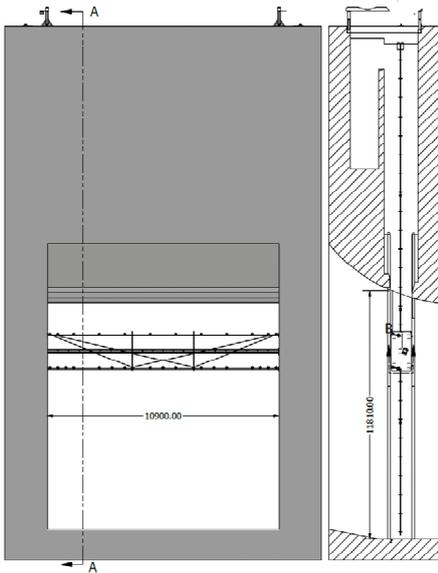
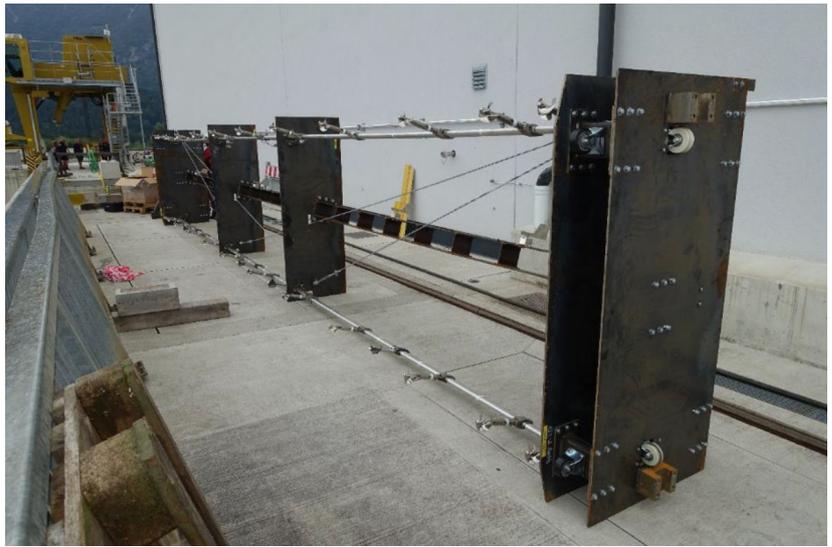
**Figure 7 Measuring Section and steel frame with sensors**

The efficiency measurement was conducted by etaeval GmbH. Twenty-four OTT C31 propellers (A-Type) were mounted on a vertically movable frame, which was then adjusted vertically in the gate slot. Two displacement methods were employed: stepwise and continuous [4]. Two different methods, namely acc. ISO 3354 and a difference method [5], were used for evaluation. Additionally, six angle sensors were affixed to the crossbeam of the frame, enabling the measurement of cross flows in a horizontal direction. Subsequent to the volume flow measurement, a correlation measurement was conducted utilising the calibrated differential pressure measurement. The ensuing results may be derived from the measurements.
