**Spillway Discharge Measurements by
Acoustic Scintillation Flow Meter in Spillway B at Mellanfallet Dam,
Alvkarleby Hydro Power Station, Sweden,
August, 1999**

Swedpower AB
SE-814 26 Alvkarleby
Alvkarlebylaboratoriet,
Sweden

W. W. Cartier, D. D. Lemon and R. A. Chave
ASL Environmental Sciences Inc.
Sidney, B.C. V8L 5Y3
Canada

ASL File No. 76-416-L

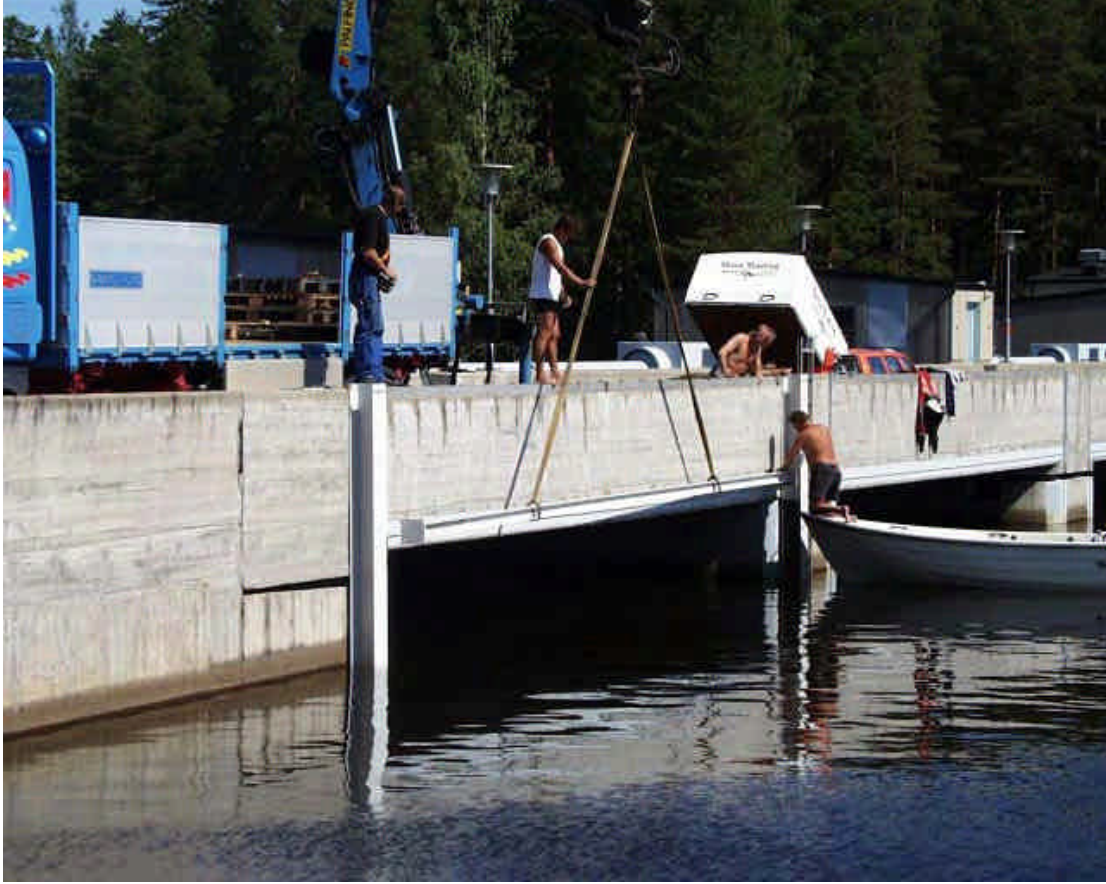
Figure 2-3: Transducer support frame being installed prior to vibration testing.

Vibration testing indicated that the frames did not have any serious vibrations through the full operating range of the spillway. Figure 2-3 shows the transducer support frame being installed for the vibrations tests without the ASFM equipment mounted. Figure 2-4 shows a detail of the vibration sensor mounted on the top of the support frame. Figure 2-5 and Figure 2-6 show flow through spillway opening during vibration testing and entrainment of air around the vertical section of the frame during vibration testing respectively.

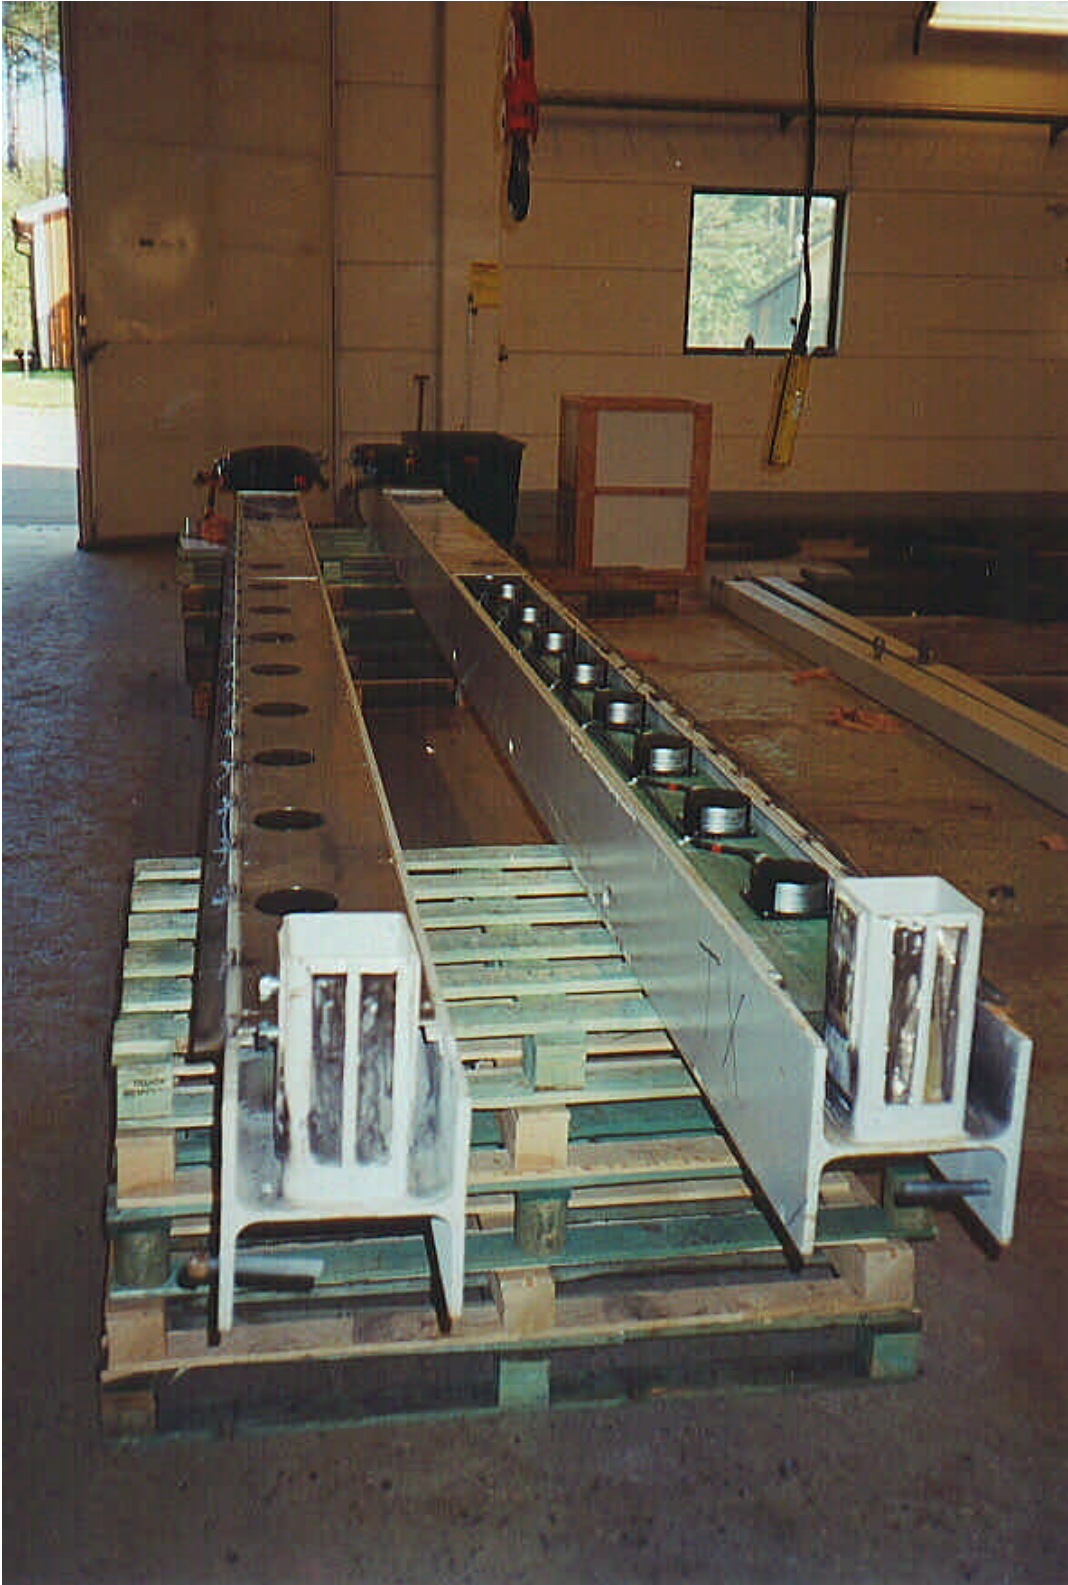
Figure 2-7: ASFM transducer support frame rigged prior to installation in spillway.

Transducers were mounted on the H-beam with the transmitters on one side and the receivers on the other as shown schematically in Figure 2-1. The open side of the H-beam was covered with a protective aluminium plate with holes for the transducers as shown in Figure 2-7. Nine acoustic levels (transducers RX1 through RX9 and TX1 through TX9), in the entrance to the spillway, were mounted on the two vertical H-beams. These eighteen transducers were cabled to the surface to six pressure cases (RX and TX), which in turn were cabled to the surface data acquisition and control system (SPS). Levels one, two and three were cabled to the first set of pressure cases (RX and TX), levels four five and six were cabled to the second set of pressure cases and levels seven, eight and nine were cabled to the third set. MSL indicates the expected mean water surface elevation. Figure 2-9 shows a photograph of the spillway in operation with the ASFM system installed.

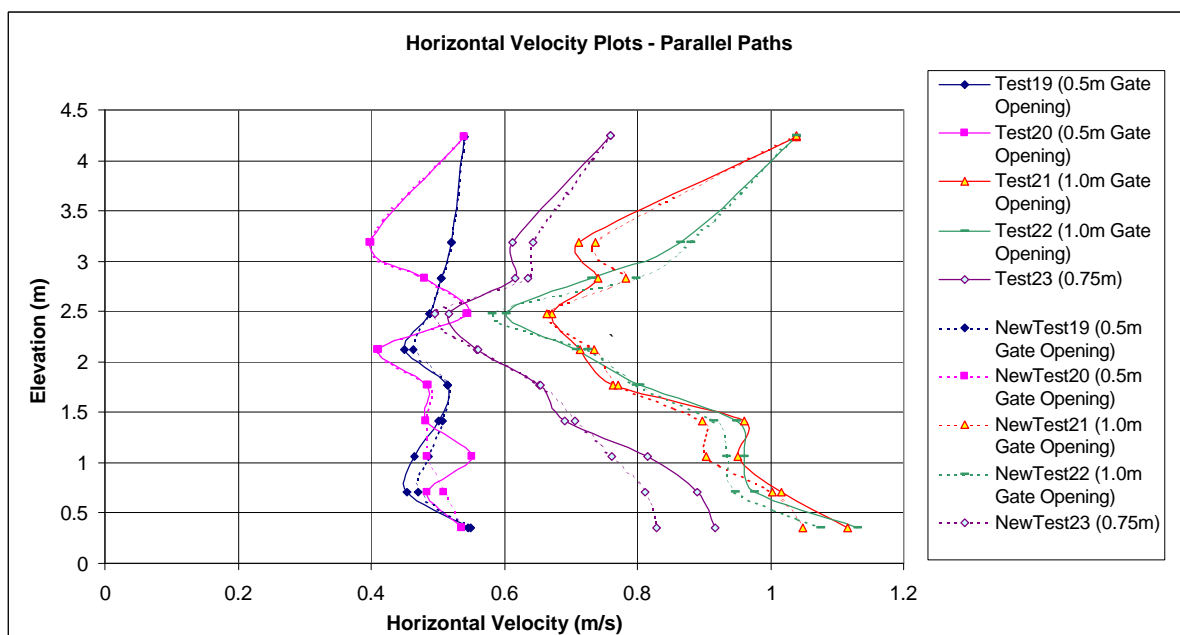
Figure 4-18: Horizontal velocity plots for parallel path data.

Horizontal velocities show a large amount of variability as shown in Figure 4-18 and all but the 0.5m gate opening seem to under-estimate the spillway discharge. Even the 0.5m gate horizontal data, as shown isolated in Figure 4-20 shows a large amount of variability and the two repeat runs at this gate opening show a 28.3% difference in the discharge estimate. Typically in hydro turbine intake studies repeat discharge estimates with the ASFM differ by less than 0.5%.
