## **Current meters discharge measurements downstream the units**

### **Test cases and general evaluations.**

**Gianalberto Grego, Fabrizio Ormando, Luca Lacitignola, Fabio F. Muciaccia**

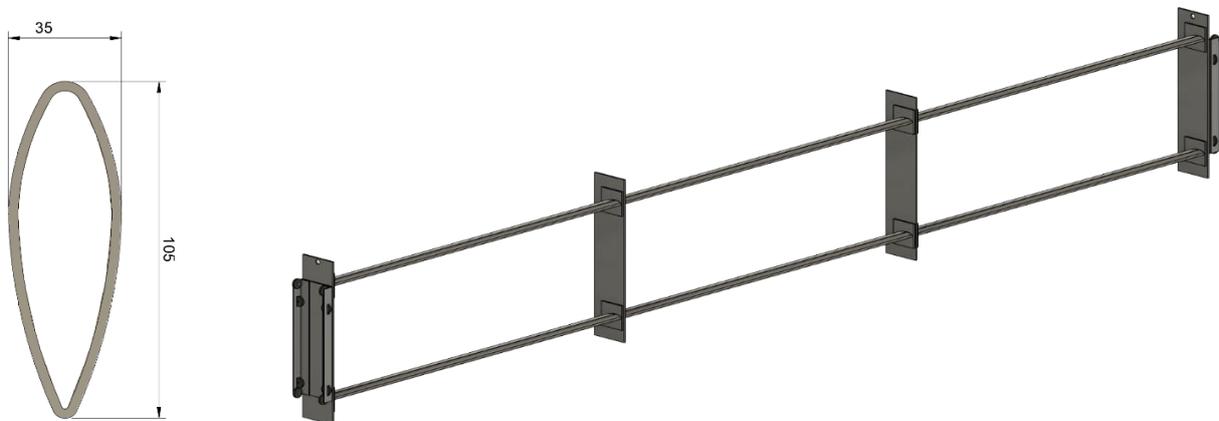
Two structures to be lowered into the valley benches were manufactured. Each structure has two 105 x 35 mm ovoidal rods on which 20 current meters (ten on each rod) were installed. The sketch of the structure and of ovoidal rods is shown. The overall weight of each structure without current meters and relevant fixing clamps, is approximately 350 kg.

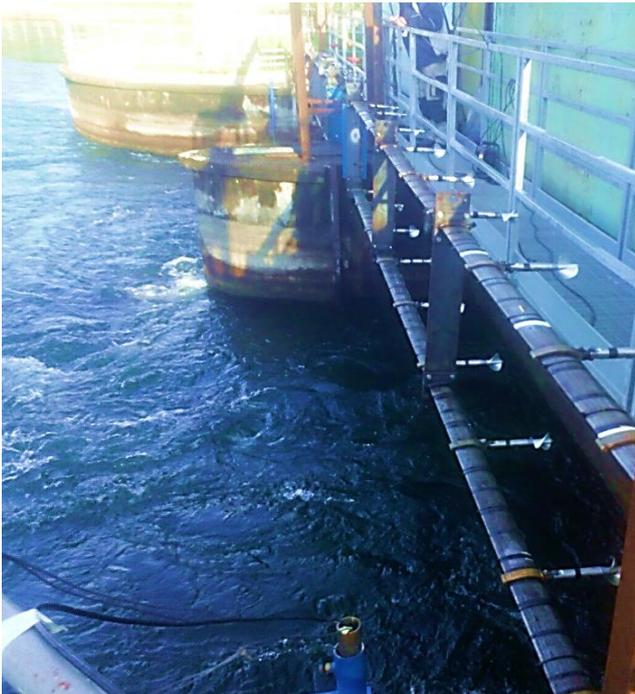
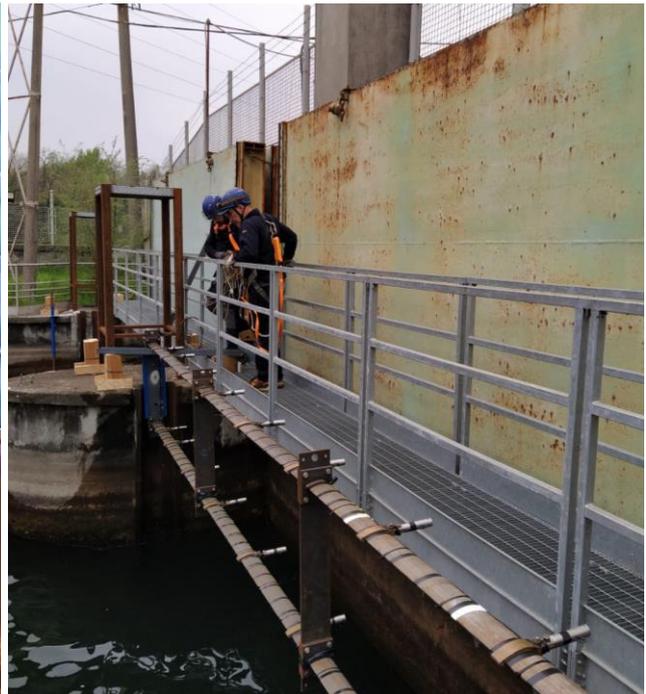
Here in after photographs of the installation.

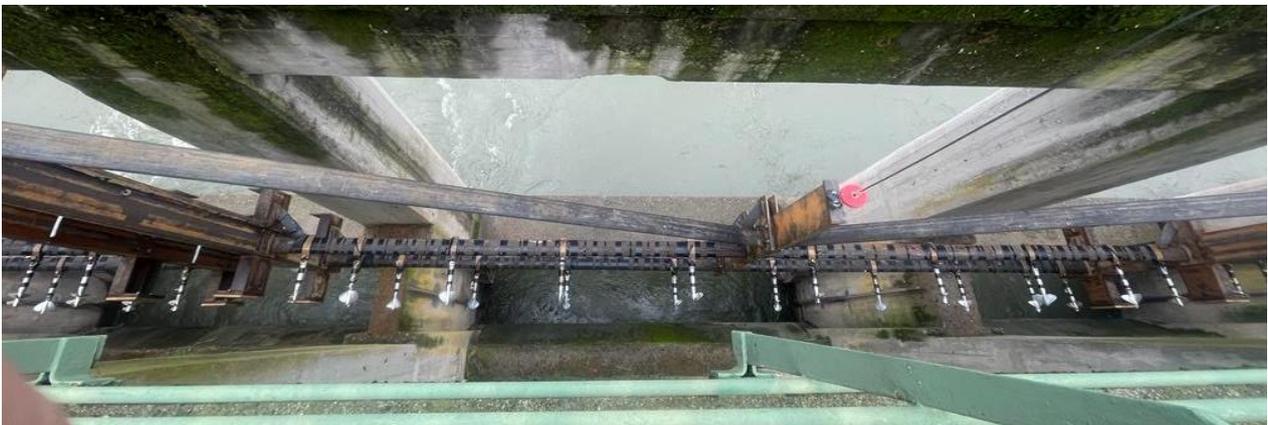
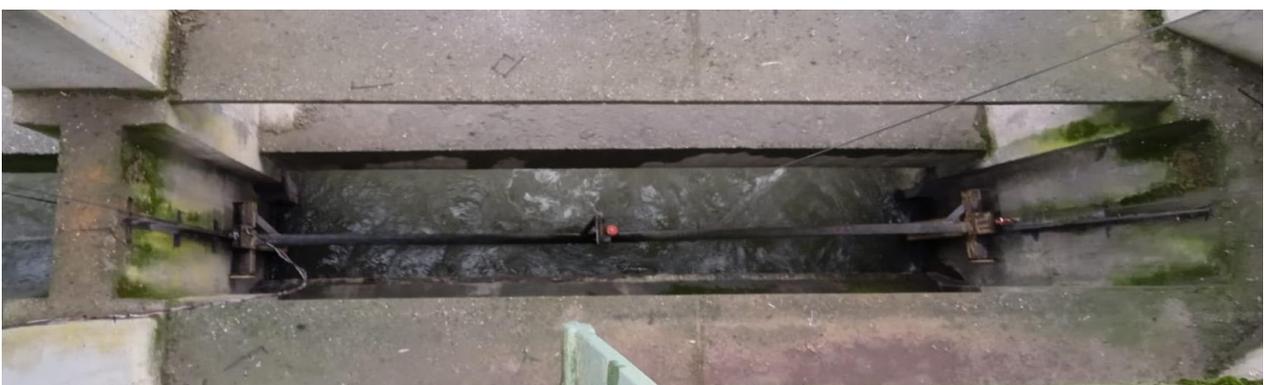
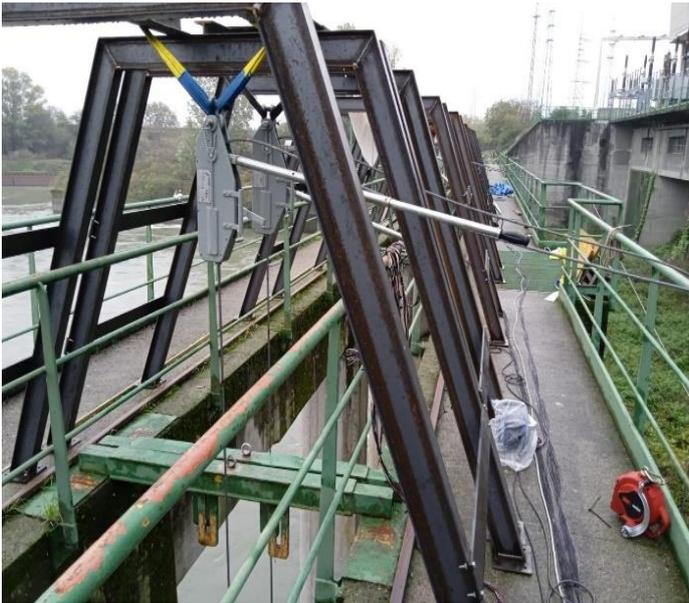
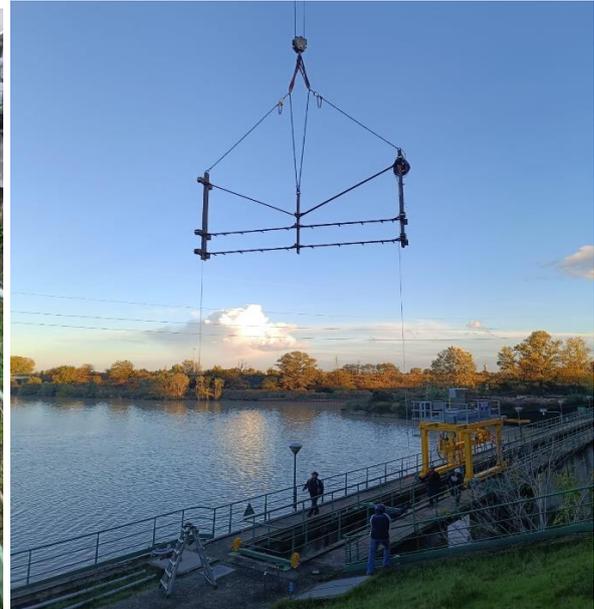
Here in after photographs of the installation.

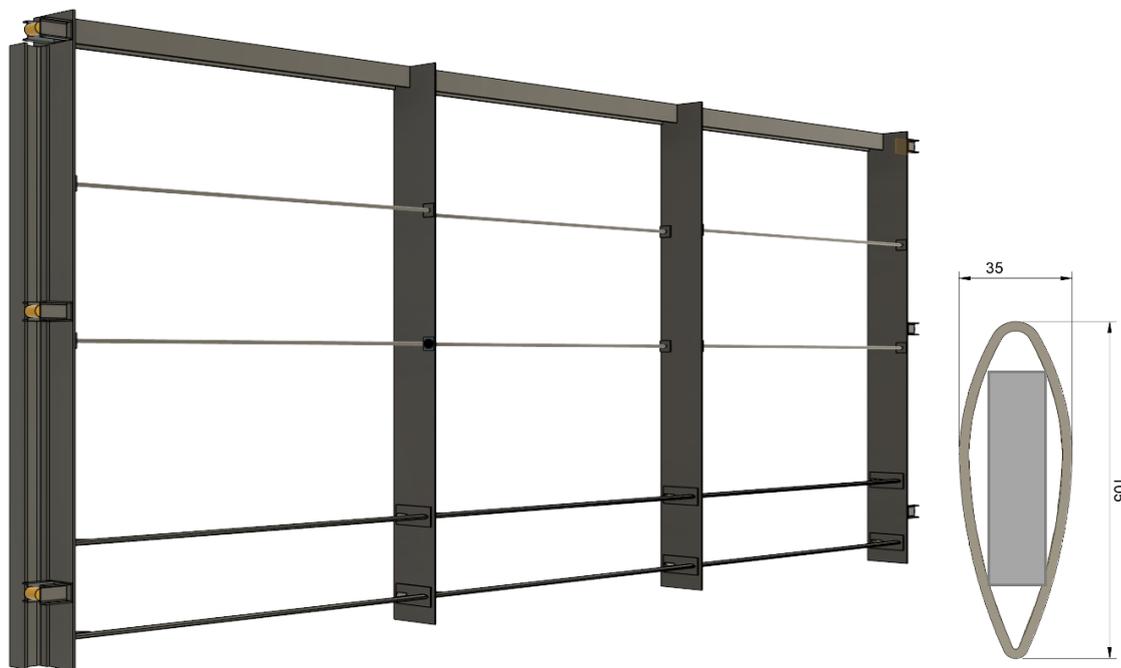
To avoid having the flow hit parts with non-hydrodynamic profiles, the structure was built with an upper support crosspiece 4.20 meters from the base of the structure (therefore never hit by the flow) and the two measuring rods in the lower part at 200 and 900 mm respectively from the free base.

The structure therefore included a very rigid frame of UPN beams along upper and lateral sides and only the two measuring rods immersed in the flow, supported by two vertical plates fixed to the upper beam. The structure, during the lifting phase, had incorrect flexural deflections and therefore stiffening horizontal rods were provided at site. Those rods however were hit by the flow although in an area very far from the current meters and therefore practically irrelevant with respect to the measurements.

It was therefore decided to insert a rectangular core hot-keyed and welded at the ends inside each of the ovoid rods, in order to adequately reinforce it as visible in the section visible above.

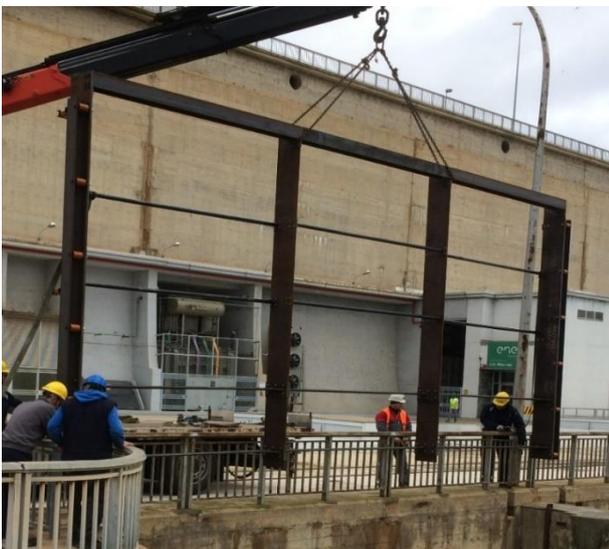
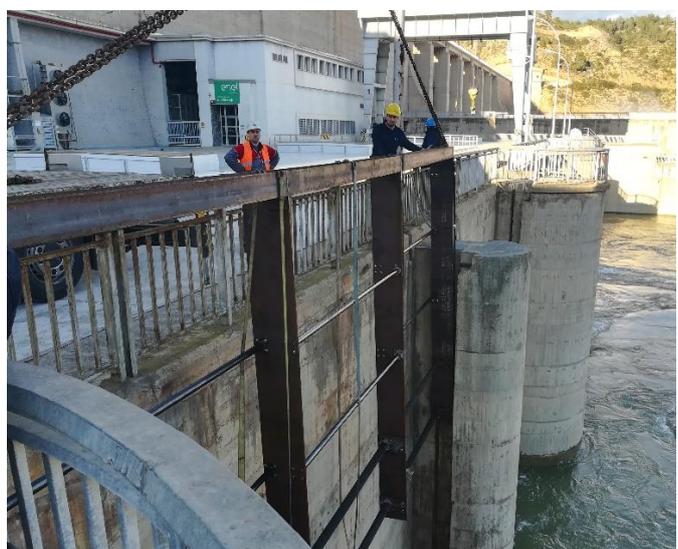
Here in after photographs of the installation.
