Field Trial of an ASFM Monitor at Lower Granite, December 2004 – January, 2005

D. D. Lemon, R. A. Chave, and M. Stone,
ASL AQFlow Inc., Sidney, BC, Canada

Presented at HydroVision 2006, Portland, Oregon

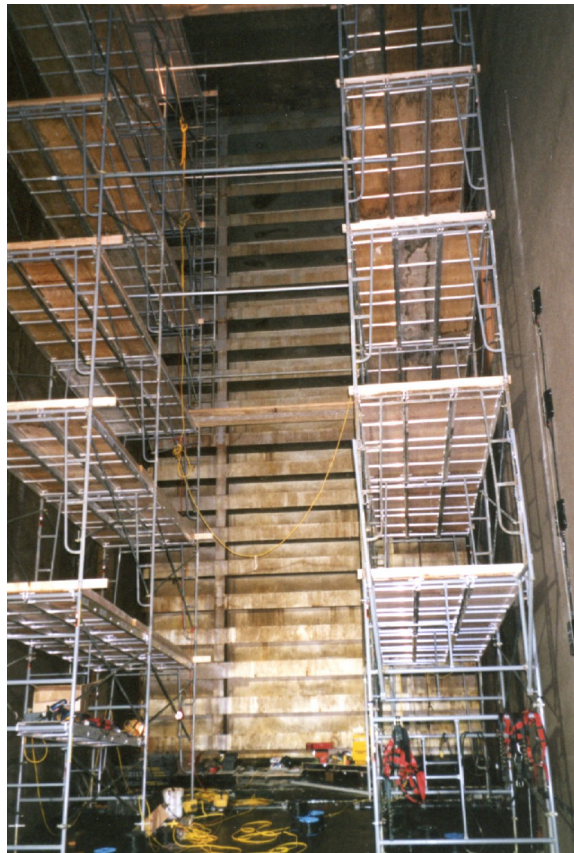
Figure 2: Interior of Bay A, Unit 4, during installation of the arrays and cabling.

Figure 2 shows the intake during the installation. The transducer arrays were bolted directly to the intake wall, and covered with a metal fairing (**Figures 3 & 4**). Cables from the arrays were attached to the intake walls, and run back to the operating gate slot, up and through an air vent into the breaker gallery. The exposed cable runs were covered with semicircular plastic pipe sections, to form a continuous conduit from the arrays to the entrance of the air vent (**Figure 5**).

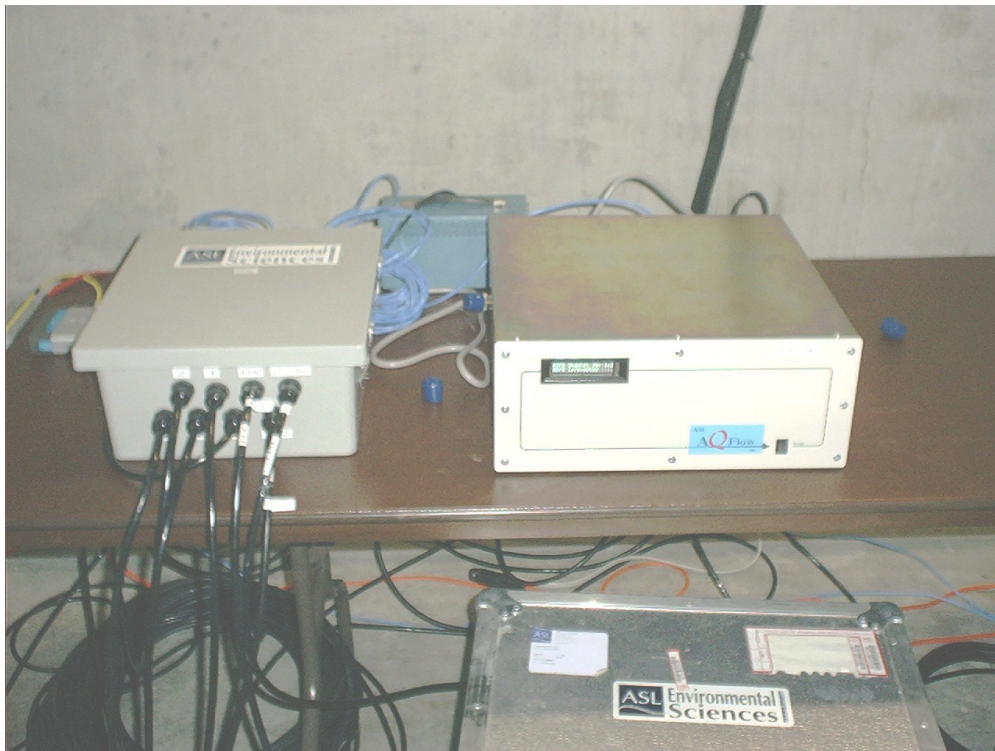
Figure 6: Monitor control unit and one switching box.

The cables were terminated inside the breaker gallery until the surface equipment was installed in December, before the beginning of the tests. **Figure 6** shows the surface equipment (consisting of two switching boxes and one control unit) in place in the breaker gallery. The control unit was connected by an Ethernet cable to the computer on the generator floor, for control and data transmission during the tests. Data were also recorded internally in the control unit.

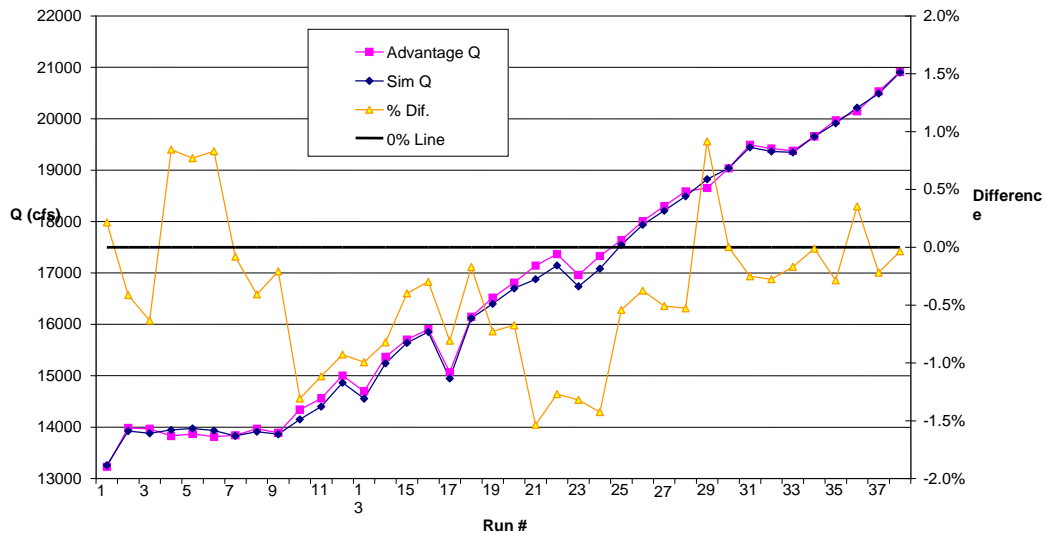
Figure 11: Discharge from simulated Monitor and ASFM Advantage (paths 2,4,6,7 & 8 selected from Bay A) Unit 4, ESBS in

The effect of the flow profile variability was further tested by selecting 5 paths in Bay A from the ASFM Advantage (paths 2, 4, 6, 7 and 8), at elevations close to those used in the Monitor, and constructing an equivalent discharge calibration table from the on-cam runs. The velocities from those 5 paths were then used to calculate discharges for all of the off-cam runs. The differences with the reference discharge (shown in **Figure 11** [ESBS in] and **Figure 12** [ESBS out]) are comparable to those found with the Monitor system. The performance of the Monitor in other configurations may therefore be usefully simulated with selected combinations of paths from the ASFM Advantage.
